PAINT FAILURE WITH INFERIOR SUBSTRATES

Independent lab accelerated weathering test results.

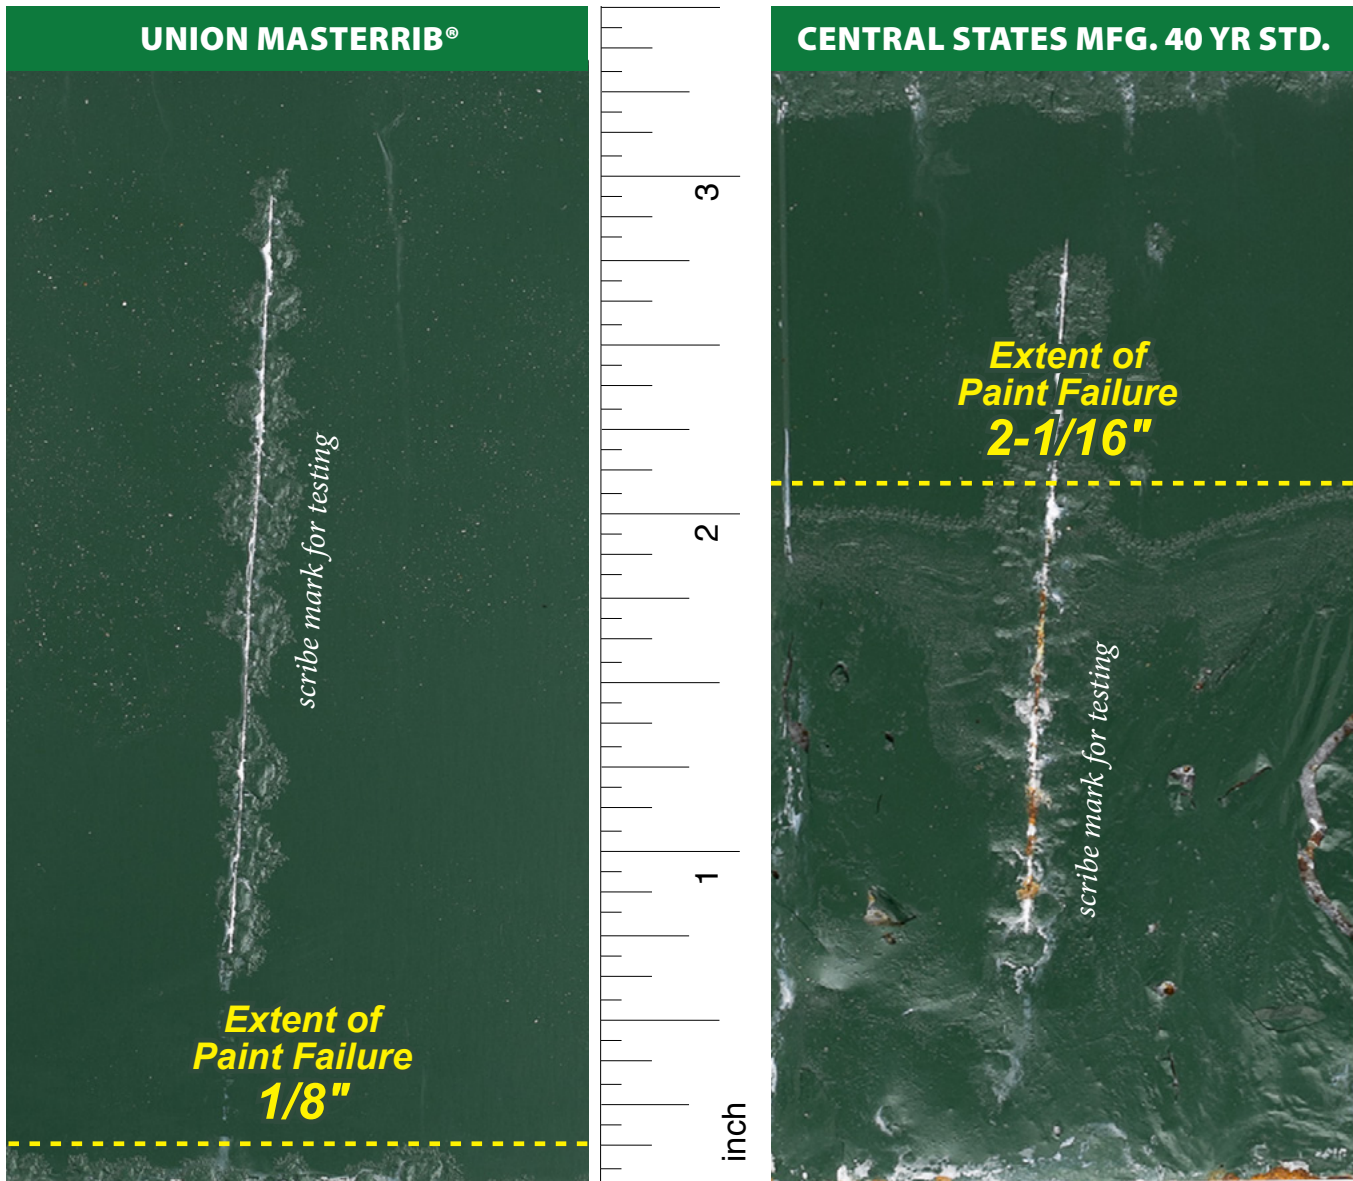
An independent testing lab performed accelerated weathering tests* of Union's MasterRib and Central States Mfg. 40 Year Standard panel. MasterRib uses an AZ50 Galvalume substrate with a corrosion warranty, while Central's panel uses a non-warranty Galvalume substrate.

- Paint failure due to edge corrosion was more than 15X worse with the non-warranty substrate.
- Paint warranties do not cover failure due to corrosion.
- Homeowners receive minimal savings yet expose themselves to high risk of failure.
- Ask your suppliers for both the paint and substrate warranties!
